### REINSTATEMENT OF HIGHWAY EMBANKMENT HIGHWAY 555, NEW MEXICO, USA

#### SOIL REINFORCEMENT RETAINING WALLS

**Product:** Terramesh®, Gabions, Gabion Mats®

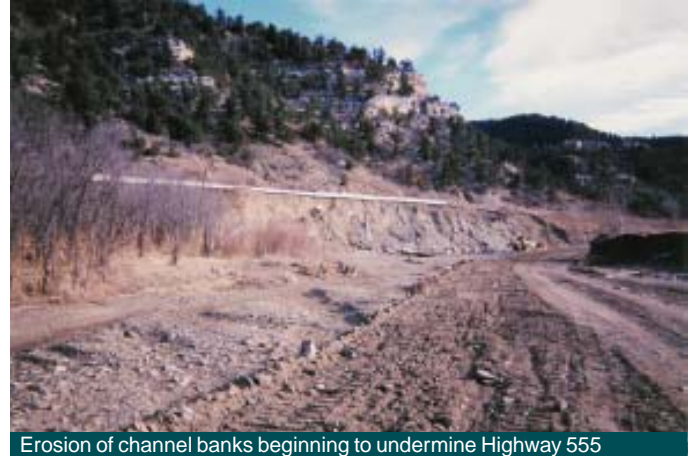
Erosion of channel banks beginning to undermine Highway 555

As the river ran parallel to Highway 555, the flooding caused severe erosion of the channel banks exposing the highway foundation; four sections of the road were washed out. In addition, the flood jeopardized the abutments of a bridge, which was in danger of becoming unstable if protection works were not implemented.

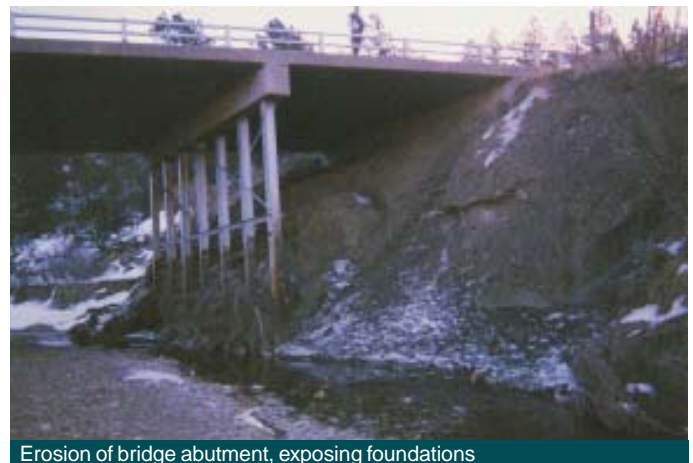
Erosion of bridge abutment, exposing foundations

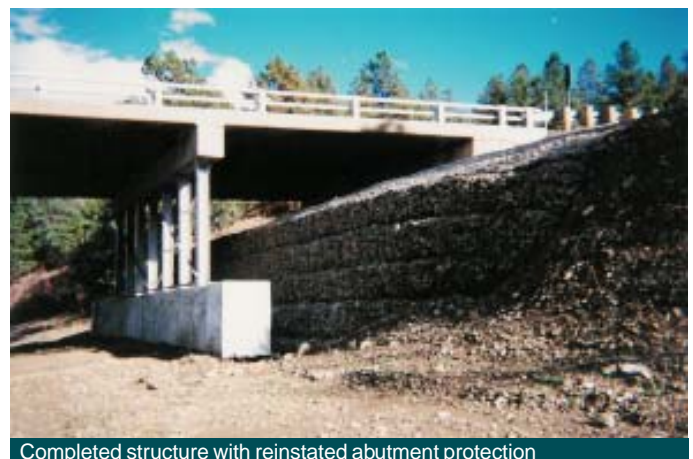
Completed structure with reinstated abutment protection

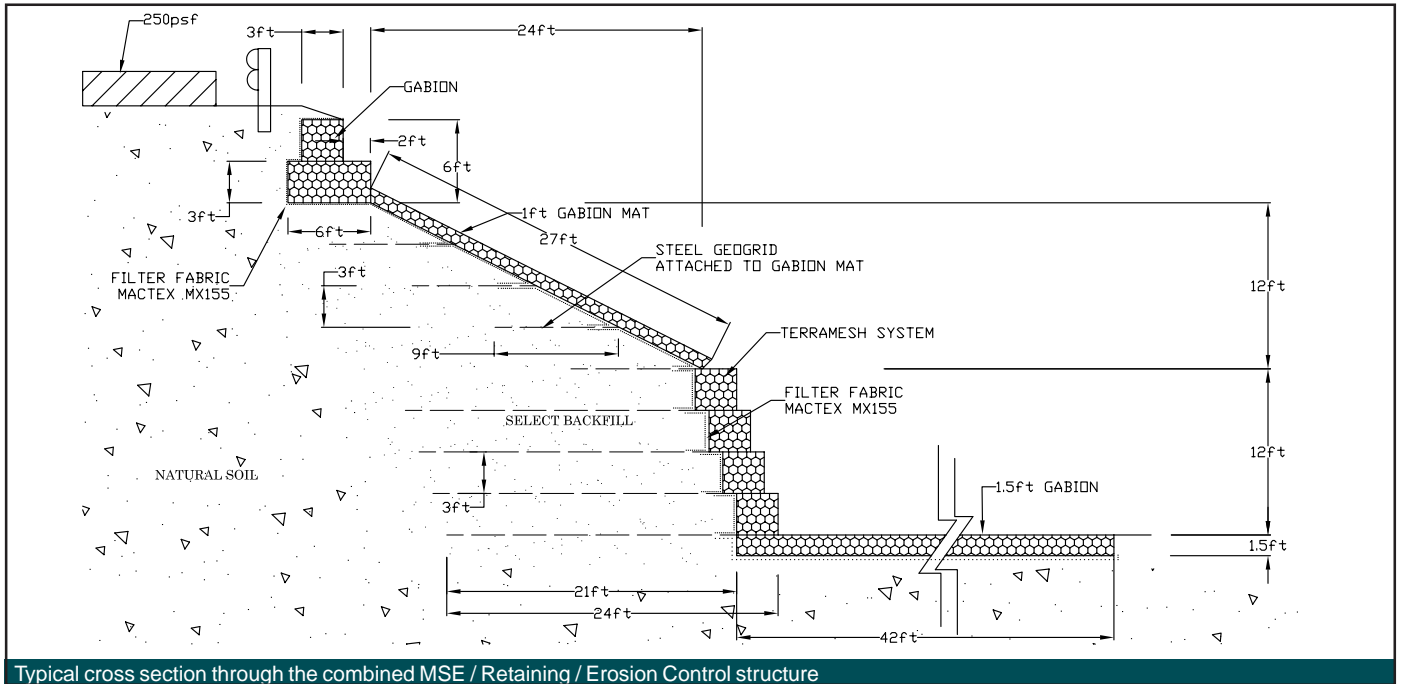
- 1.5' thick Gabion Mat® scour protection apron / foundation
- 12' high Terramesh® mechanically stabilized earth structure
- 1' thick Gabion Mat® erosion protection upon a 2:1 slope
- 6' high gabion retaining wall

Where necessary, the slope above the Terramesh® wall was not only protected by Gabion Mats®, but also reinforced with geogrids to ensure the structural stability of the system. The geogrids were the same double twisted PVC coated steel wire grids used in the Terramesh®. This enabled the Gabion Mats® on the slope face to be secured to the geogrids reinforcing the slope - see typical cross section.

In certain locations, it was also necessary to construct gabion foundations beneath the Terramesh® MSE structure.

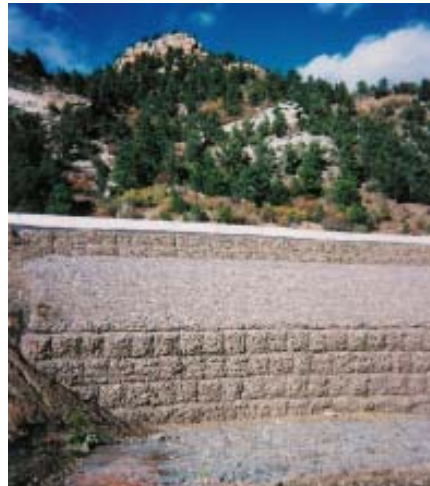
Completed structure adjacent to bridge abutment

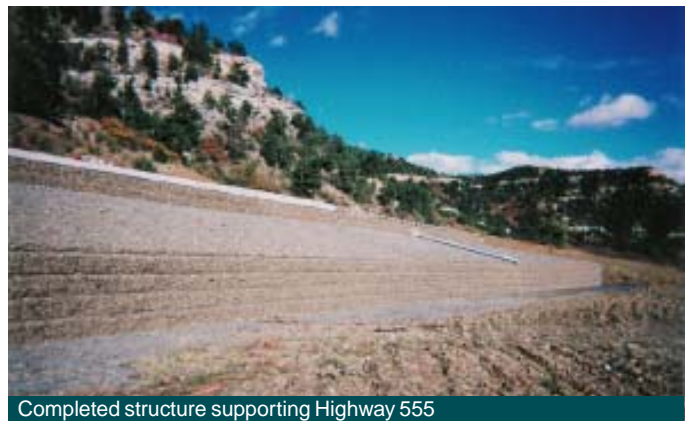
Completed structure supporting Highway 555

The MSE and gabion structures not only retained Highway 555, but also provided erosion control and training works for the Canadian River at the foot of the structures. Because Terramesh®, Gabion Mats® and Maccaferri gabions are manufactured from **double twist woven steel wire mesh**, they can accommodate large differential settlements without rupturing, 'unzipping' or sustaining damage.
