POTHOLE REPAIRS TO PAVEMENT MATTHEWS, NORTH CAROLINA, USA

ROAD PAVEMENT REINFORCEMENT—FATIGUE CRACKING REPAIRS

Product: Road Mesh™

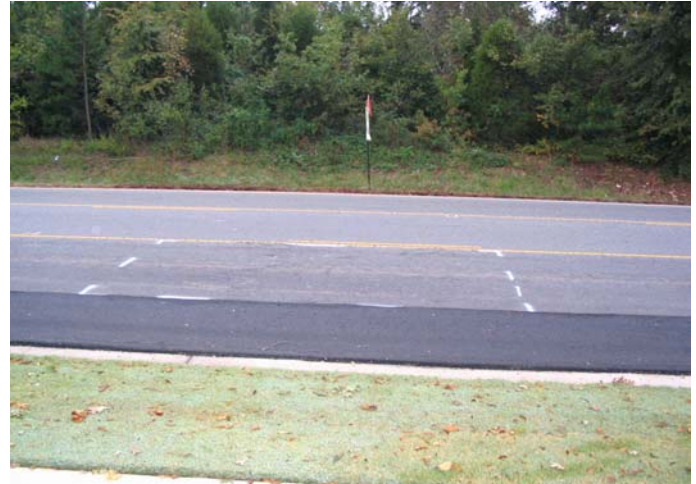
Existing fatigued area

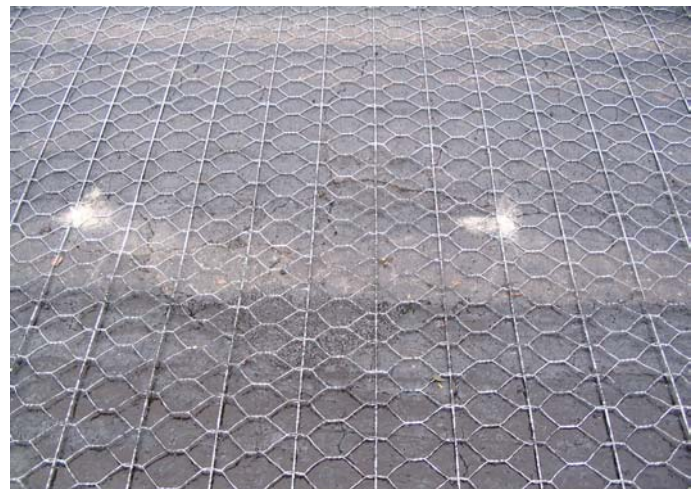
Road Mesh™ secured using Hilti™ fixings

Two areas were treated with Road Mesh™; a 25' long section and a 40' long section. Panels of the mesh were cut and placed over the cracked area, so that 6' (1.83m) of mesh extended beyond the edges of the cracked area. To stop it moving during paving operations, the Road Mesh™ was secured to the pavement surface using 2.5" (63.5mm) long Hilti™ sleeved nails drilled into the pavement surface.

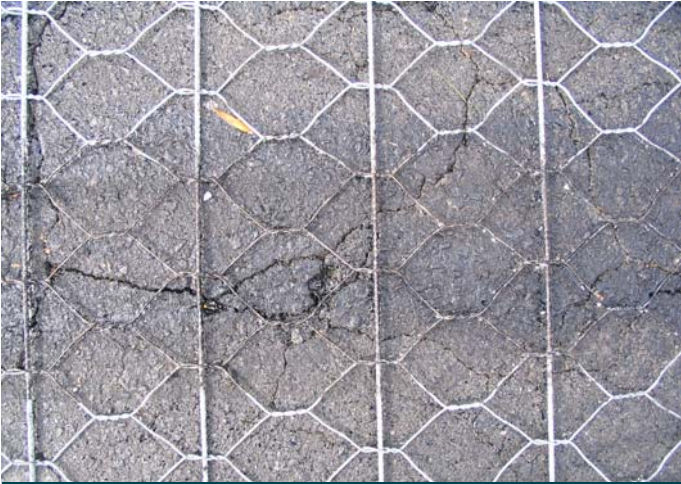
Detail of crack beneath Road Mesh™

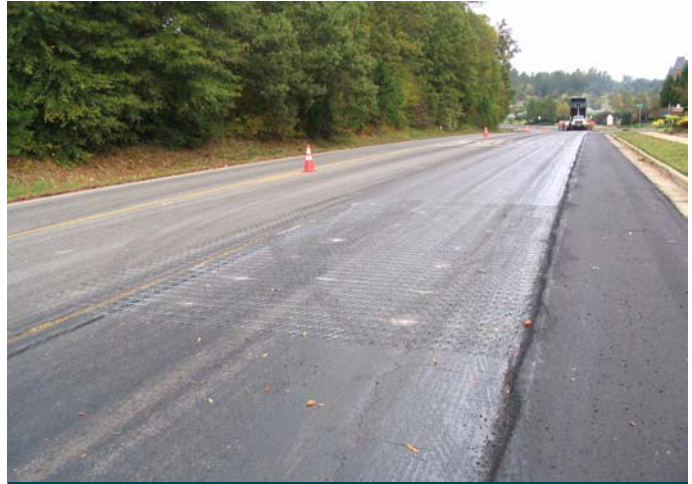
Fixed Road Mesh™ ready to receive wearing course

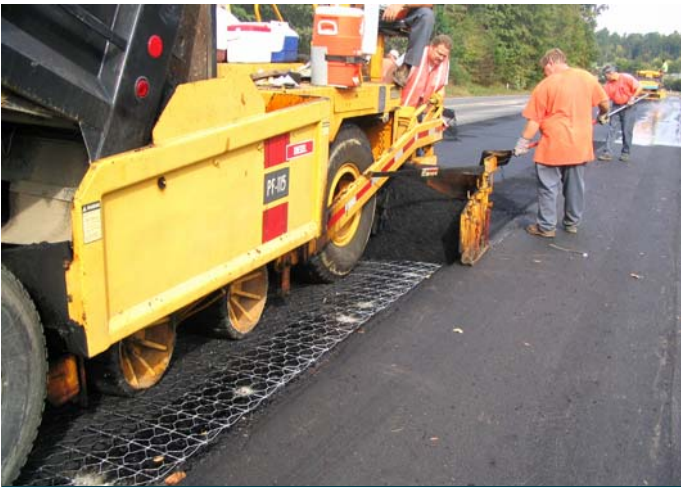
Placing asphalt using wheeled paver

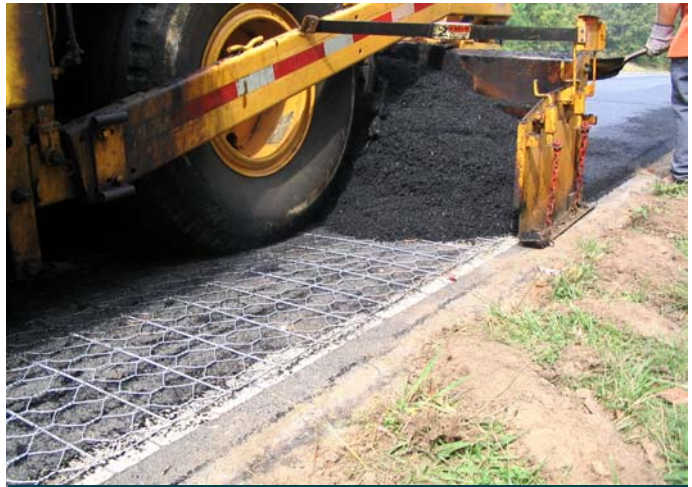
Placing new wearing course

The entire pavement surface was then paved with 2" (50mm) asphalt wearing course and then rolled.

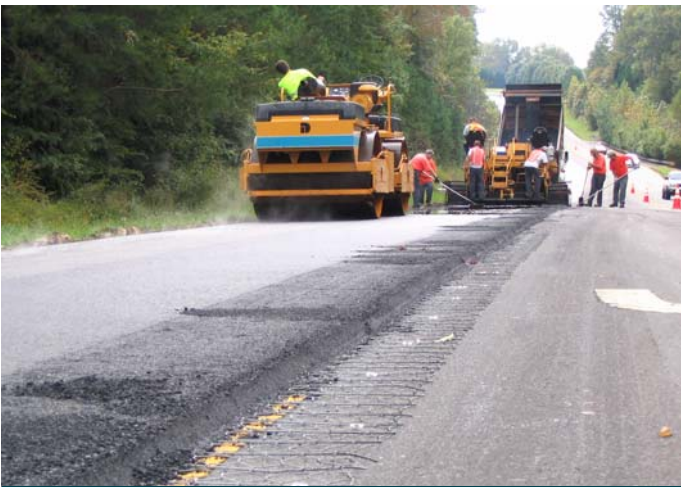
Rolling asphalt wearing course

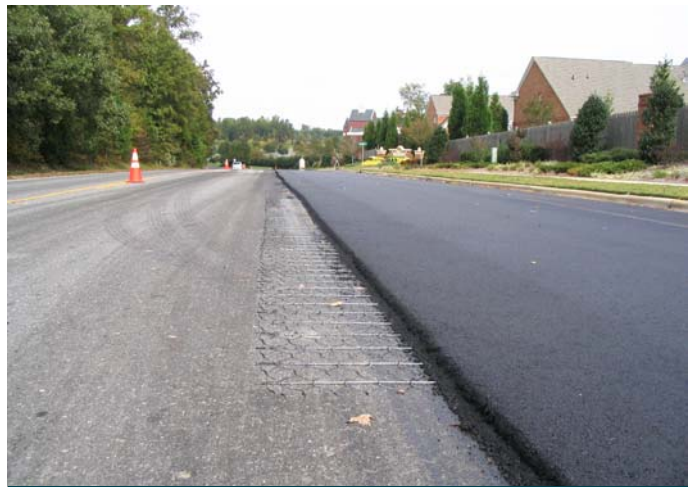
Road Mesh™ overlap to reduce construction joint cracking
